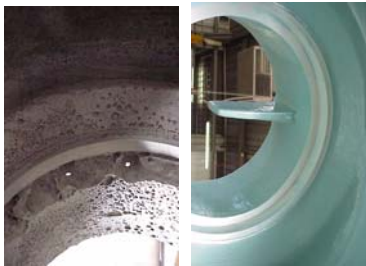
Condenser Water Pump

Severely Corroded Ajax Pump

Left is the pump inlet as we received it. Note the deep pits and holes in the casing. Right is the pump after repair and rebuild with Corroglass 600 series. The cause of the damage, corrosion, has been eliminated and the pump can be put back into service for many more years.

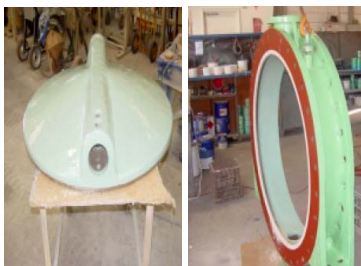
Cost Effective Valve Refurbishment

48" Butterfly Valve Refurbishment

The valve flap and body had deep pits and metal loss around the sealing edges. As a result the valve had become totally ineffective. The valve was totally refurbished old for new with a 20 year life expectancy. The refurbishment of an existing valve can provide considerable savings over expensive metal castings or new valves with changes to pipework.

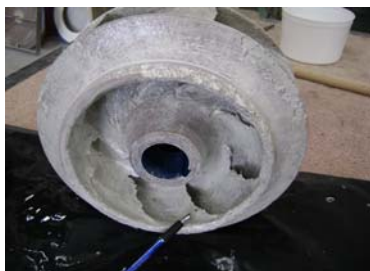
Sea Water Pump

Impeller Vanes Rebuilt

This impeller has been blasted, treated for salt contamination and primed with one coat of Corroglass 600. Note the severely corroded impeller vanes. They were rebuilt using a composite of Kevlar matting and 600 series. After coating the impeller is balanced and Fluiglide is applied to reduce friction and increase efficiency.

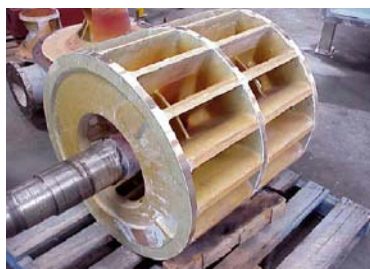
Nash Acid Vacuum Pump

Refurbished

Ten years prior to this photo the pump was considered scrap due to its badly corroded condition and loss of efficiency. The pump was fully refurbished by Corrocoat and after ten years shows no signs of corrosion. As well as the obvious savings in replacement costs, the original cause of the failure, corrosion, is eliminated and there is no need to change piping or footings

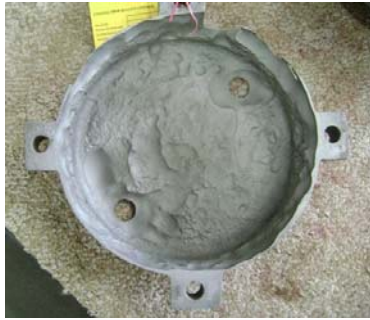
Sea Water Condenser End Covers

Significant metal Loss

This condenser end cover was considered scrap, however Corrocoat were able to rebuild it using a composite laminate of 600 series and Kevlar matting. Two stainless steel sockets were welded in place and the end covers put back into service without the risk of future corrosion, and at a fraction of the replacement costs.

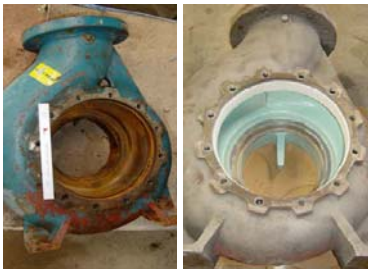
Pump Overhaul

Cast Iron Water Pump – Southern Cross

The photo on the left shows the pump severely corroded and eroded with considerable metal loss due to acidic water. Prior to Corrocoat's involvement the pump was being replaced every 6 months. The photo right shows the fully refurbished pump which will operate with no corrosion at reduced power consumption and no loss of production.

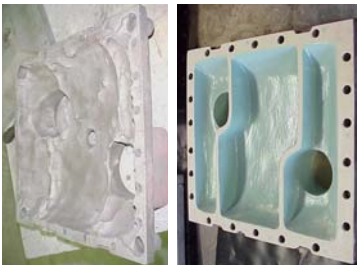
Ship Lady Elaine

Water Box Rebuild

Left: This water box was removed, blasted and decontaminated revealing severe corrosion, holes through the casing and the division plates almost completely corroded away.

Right: The same water box fully refurbished with 600 series and Kevlar matting.

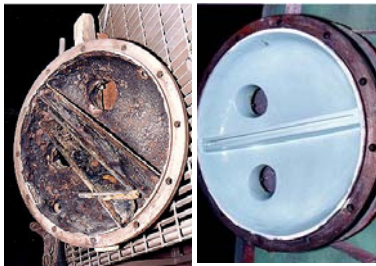
Shell & Tube Heat Exchanger End Covers

Sever Metal Loss Due to Sea water and Galvanic Corrosion

This cast iron end cover had been in service for 2 years and was severely corroded. The division plate was rebuilt with 600 series and matting. The sealing faces brought back to their original dimensions. The end cover is now corrosion protected and will provide many more years of trouble free service.

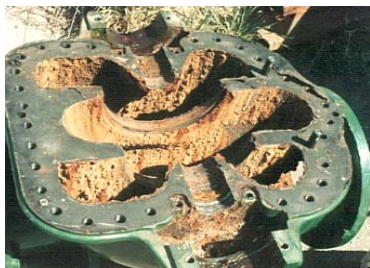
Worthington Pump

Cost of Repairs Paid Back in 15 months Due to Reduced Power Consumption

Severe corrosion, deep pitting and corrosion deposits resulted in poor performance, increased pumping costs and its untimely failure. All internals were rebuilt and re profiled using 600 series. The wear rings and landings were built up with Corroglass and machined to original size. A top coat of Fluiglide was applied to reduce friction and the savings in power consumption paid back the repairs in 15 months.
