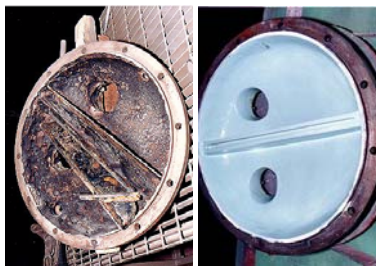
Shell & Tube Heat Exchanger End Covers

Sever Metal Loss Due to Sea water and Galvanic Corrosion

This cast iron end cover had been in service for 2 years and was severely corroded. The division plate was rebuilt with 600 series and matting and the seal faces brought back to original tolerances. The end cover is now corrosion free for many years service.

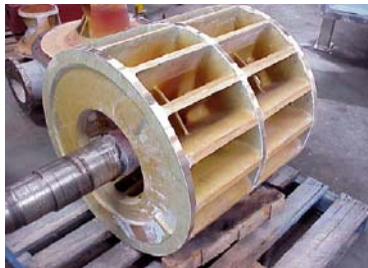
Nash Acid Vacuum Pump

Ten years prior to this photo the pump was considered scrap due to its badly corroded condition and loss of efficiency. The pump was fully refurbished by Corrocoat and after ten years shows no signs of corrosion. As well as the obvious savings in replacement costs, the original cause of the failure, corrosion, is eliminated and there is no need to change piping or footings.

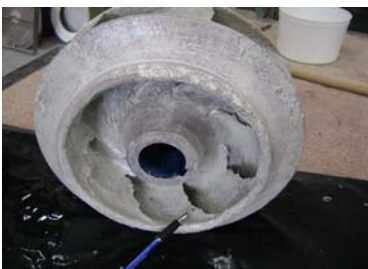
Sea Water Pump Impeller Rebuild

This impeller has been blasted, treated for salt contamination and primed with one coat of Corroglass 600. Note the severely corroded impeller vanes. They were rebuilt using a composite of Kevlar matting and 600 series. After coating the impeller is balanced and Fluigluid is applied to reduce friction and increase efficiency.

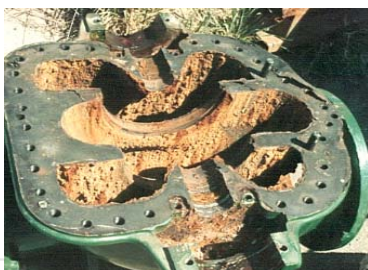
Worthington Pump

Severe corrosion, deep pitting and corrosion deposits resulted in poor performance, increased pumping costs and its untimely failure. All internals were rebuilt and re profiled using 600 series. The wear rings and landings build up with Corroglass and machined to original size. A top coat of Fluigluid was applied to reduce friction and the savings in power consumption paid back the repairs in 15 months.

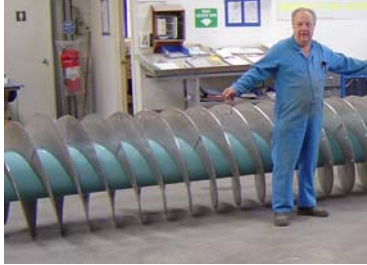
Screw Coating

This 15 meter long screw together with the classifier tank was corrosion protected with Polyglass VEF and the screw with 600 series. The process conditions are pH 5 to 9, chlorides to 2000ppm, sulphides to 3200ppm, operating temperatures from 87°C to 95°C.

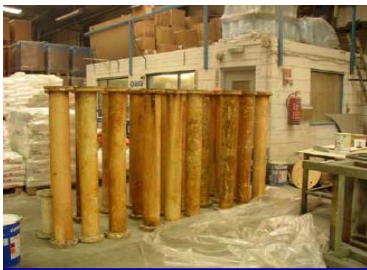
Seawater Pump Riser Pipes

These pipes were originally coating in 1983 with Corroglass 600 series. They were exposed externally to seawater (immersed, splash zone & atmospheric) & internally with sea water for before being removed for inspection in 2004. The coating was found in excellent condition, touched up & the pipes put put back into service.

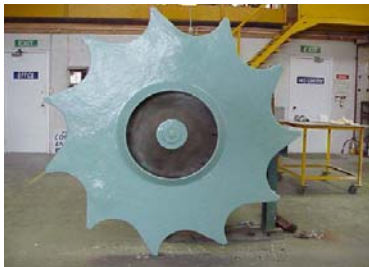
Duplex Stainless Steel Fan

This fan impellor suffered severe erosion and corrosion of the blades, cracking of welds, and thinning of the metal. Uncoated the impellors service life was less than 3 months. The service life was increase to more than 2 years after which the coating can be repaired.

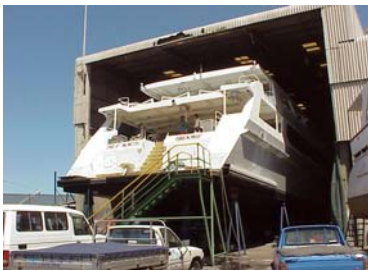
Marine Repairs

The engine and generator exhaust piping on this vessel was badly corroded which was resulting in fumes and salt water leaking into the engine room. Corrocoat were contracted to undertake repairs to the piping and internal anti corrosion treatment to prevent any future corrosion.

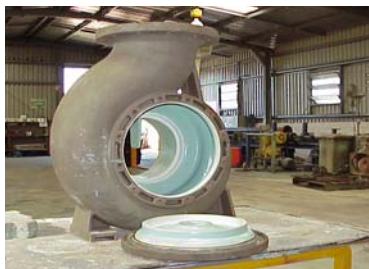
Pump Rebuild

This pump was badly corroded and the owners were faced with replacing the pump. Corrocoat rebuilt all internal surfaces to the original profiles of this pump with Corroglass 600 series. The pump was rebuilt for 50% of the cost of a new pump, all corrosion issues were eliminated, pump efficiency improved and was back in service before a new pump could be supplied.
