### BHP Petroleum- Griffin Venture North West Shelf Pipework coating

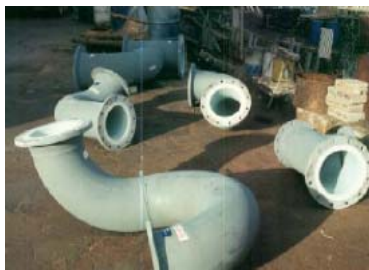
Warm seawater corroded the existing Stainless Steel pipe spools. BHP specified Corrocoat to internally coat new carbon steel pipe spools as part of a major refit. By eliminating the need to regularly replace the pipes together with unplanned shutdowns and lost production, significant savings were achieved with this anti corrosion system.

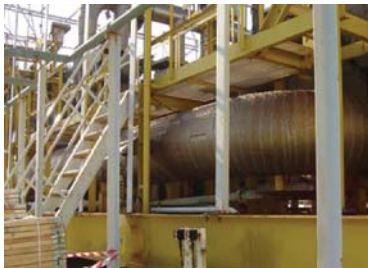
### Prover Loop Protection Accurate Measurement of Crude Oil Flow

For a prover loop to accurately measure the crude oil, minimal surface friction and a long term corrosion protection is critical. Corrocoat's VEF & Fluiglide provided the perfect solution for this carbon steel prover loop in the Middle East. Corrocoat's pipe blaster and sprayer are designed and manufactured in house to match the requirements of Corrocoat materials.

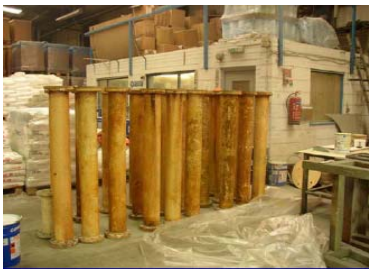
### Seawater Pump Riser Pipes After 21 Years of Service

These pipes were originally coated in 1983 with Corroglass. They were exposed, externally to seawater (immersed, splash zone & atmospheric) & internally to warm sea water before being removed for inspection in 2004. The coating was found to be in excellent condition, touched up & the pipes put back into service.

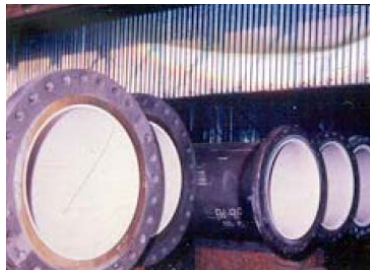
### Oil & Gas Sea Water Caissons & Riser Pipes

Warm seawater with high velocities and entrained solids resulted in high maintenance costs and lost production to repair the original rubber lining. The rubber was replaced with a Corrocoat VEF coating using an internal pipe sprayer. Time in service without maintenance 18 years.

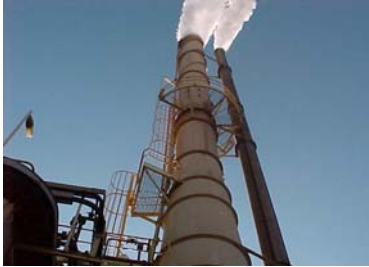
### High Temperature Acid Attack

This flue suffered from high temperature sulphuric acid fumes condensing on the wall. Although rubber lined, the metal loss was unacceptable on certain sections of the flue. After removal of the rubber lining the new and existing sections were all coated with Corrothane XT to prevent any further acid attack of the mild steel flue.

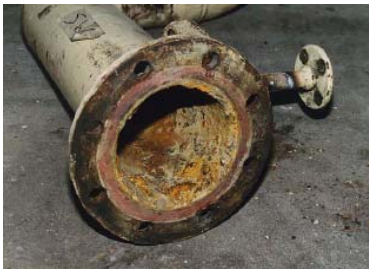
## Low Cost Epoxy Coating Failure

This pipe was coated with a low cost epoxy coating and had failed after 9 months due to poor preparation, heavy salt contamination, low bond and high permeation. Corrocoat removed the faulty coating, decontaminated the substrate and lined the pipe with Corroglass 600 series. The pipe has been in service for over 10 years with no problems.

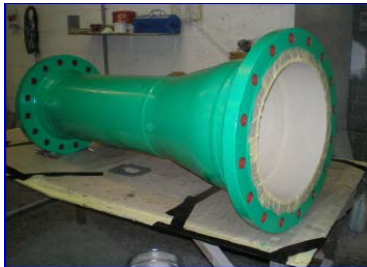
## Seawater Fire Main

This reducing spool forms part of a seawater fire main. Without protection severe corrosion would occur rapidly in this aggressive sea water environment. The design life of the firemain was 15 years so Corrocoat was selected to provide corrosion protection internally with 600 series and external protection with ZF.

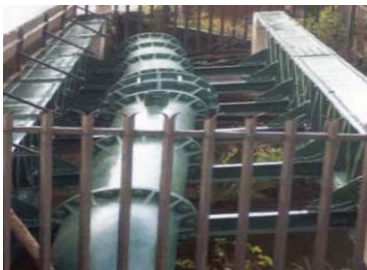
## Pipe Bridge Restored

A structural survey revealed this pipe bridge required extensive repairs and corrosion protection. After the repairs the entire structure and pipe externals were treated with two coats of Plasmert ZF. The bridge and pipe were re inspected 7 years later and found to be corrosion free.

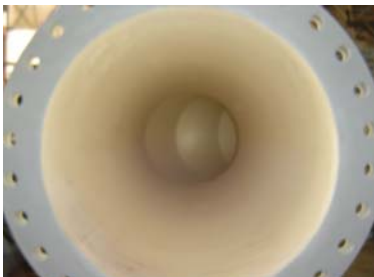
## Rubber Lining Replaced

The process conditions in the pipe work include steam, sulphuric and hydrochloric acid with some solids at 120°C. The existing rubber lined, carbon steel, pipe work had failed quickly due to acid attack. The new pipe work was lined with Corrothane XT and provided excellent long term protection.
