Oil & Gas

Coarse Water Strainers

Industry: Oil & Gas
Product: Polyglass VEF & Armagel
Expertise: Internal coating of tanks and pressure vessels

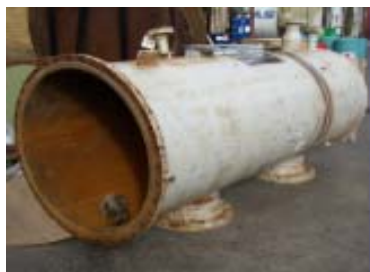
During the “algae bloom” period the baskets were removed several times a day causing mechanical damage to the coating. Corrocoat offered a solution of stainless steel impact rings and internally coated the internals with a corrosion and abrasion resistant lining. The strainers are now lasting in excess of 12 years before requiring maintenance.

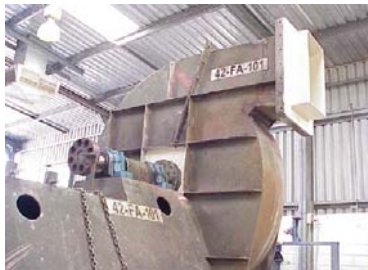
Tiwest Chandala Fan Rebuild

Severe Erosion & Corrosion of Duplex Stainless Steel Fan Casing & Impeller

This fan was severely corroded and eroded from wet sulphuric acid and H₂S with abrasion from mineral sand. Significant savings were achieved by eliminating the need for a new fan and associated modifications to existing footings and ductwork. The coating prevents any future corrosion / erosion reducing maintenance and running costs.

Industry: Mining
Product: Polyglass VEF, Corroglass 600 series & Armagel
Expertise: Rebuild all internal surfaces to original profiles

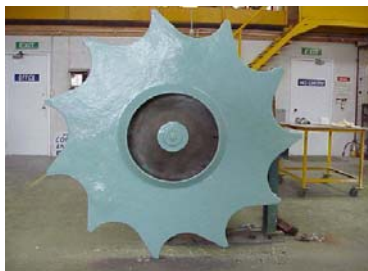
Duplex Stainless Steel Fan

This fan impellor suffered severe erosion and corrosion of the blades, cracking of welds, and thinning of the metal. Uncoated the impellors service life was less than 3 months. The service life was increase to more than 2 years after which the coating can be repaired.

Industry: Mining
Product: Corroglass 600 series & Armagel
Expertise: Hand coating of equipment

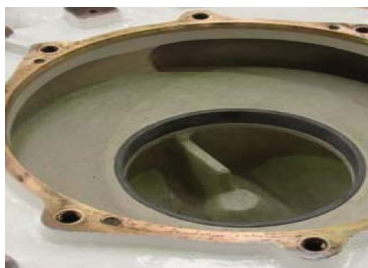
Refurbishment & Coating Hamworthy Pump Casing

Armagel is a durable coating offering excellent abrasion and chemical resistance. Armagel may be used on its own or as a top coat for Corroglass and Polyglass materials. This cast bronze pump casing was internally lined with 600 series followed by Armagel. Two coats of ZF were applied to the external of the pump casing.

Industry: Marine
Product: Corroglass 600 series, Armagel, Plasmjet ZF
Expertise: Repairs and Rebuilds
