Prover Loop Protection

Accurate Measurement of Crude Oil Flow

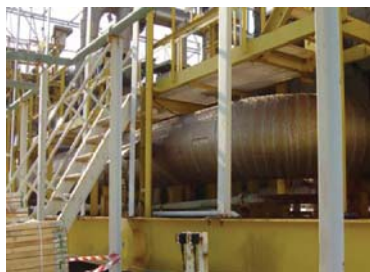
For a prover loop to accurately measure the crude oil, minimal surface friction and long term corrosion protection is critical. Corrocoat's VEF & Fluiglides provided the perfect solution for this carbon steel prover loop in the Middle East. Corrocoat's pipe blaster and sprayer are designed and manufactured in house to match the requirements of Corrocoat materials.

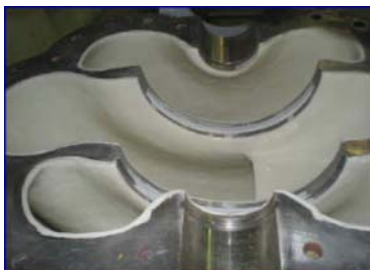
Fluiglides Treatment of 14/12 HSC Pump

Corrocoat regularly treat new pumps for the pump manufacturers. This pump was treated with 600 series to prevent corrosion, followed by one coat of Fluiglides which typically improves efficiency by 4-6%. An external coat of ZF is applied to provide corrosion protection to the exterior of the pump.

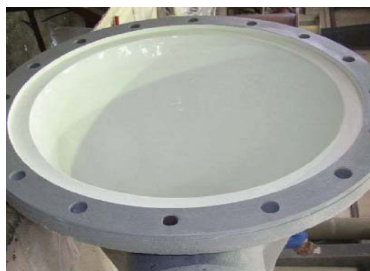
Sea Water Venturi

Cavitation, Undercutting & Severe Corrosion Around Flange Area

Corrocoat EA and EB series provide good resistance to erosion, cavitation and impact when used at thicknesses above 1.5mm. These cast iron components were originally glass lined and were fully refurbished with the above Corrocoat system.

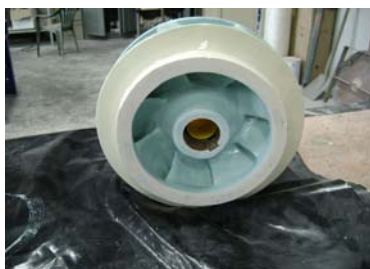
Sea Water Impeller

This bronze impeller was severely corroded from the sea water environment and required considerable rebuild work using 600 series and Kevlar matting. The outer faces of the impeller were coated with 200 microns of Fluiglides giving it a smooth finish thereby increasing pump efficiency and reducing power consumption.
