Water Industry Australia

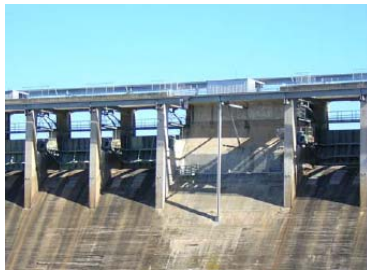
Spillway Gates— Victoria

Industry: Water
Product: Polyglass VEF, HTE
Expertise: External coating of structural steel

Access to the gates was difficult and expensive and the original coating required maintenance after two years. Corrocoat removed the existing coal tar epoxy and replaced it with Polyglass VEF. HTE was applied to the rubbing areas because of its excellent abrasion resistance. The new coating has required no maintenance for 9 years.

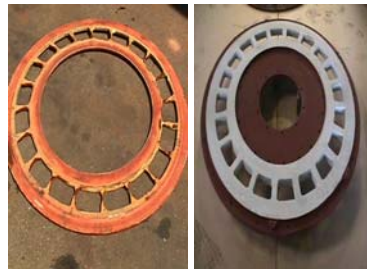
Rebuild Filter Ends

Concentratro Fines Treatment Plant

Industry: Mining
Product: Corroglass 600 Series & Plasmnet HTE
Expertise: Rebuild Components

On the left is the badly corroded / eroded cast iron filter end. On the right is the same filter end fully refurbished using a combination of 600 series and HTE. Unprotected filter ends have a working life of 4 months. When protected the filter ends last 18 months and can be repaired indefinitely at $\frac{1}{3}$ the replacement cost.

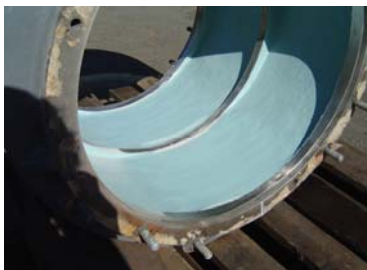
Nash Pump Refurbished

Poor Vacuum and Excess Energy Consumption

Industry: Process
Product: Corroglass 600 Series, Plasmnet HTE
Expertise: Repairs and Rebuilds

After only 5 years in service this vacuum pump had severe pitting corrosion and metal loss. The performance of the pump had reduced together with increased energy consumption. HTE with its excellent abrasion and impact resistance was applied to all high wear areas.
