### Oil Cooler Heat Exchanger

**Corrocoat Repair Corroded Tube Sheets.**

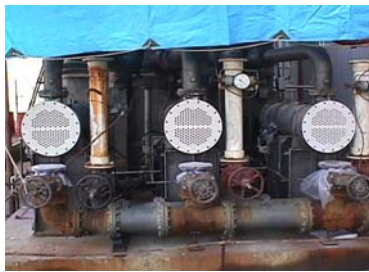
These heat exchangers were originally epoxy coated. On inspection the tube sheets were badly corroded and the client considered replacement of the tube sheets and tubes with 8 weeks down time. Corrocoat repaired and coated the existing sheets with 600 series in 4 days and at 10% the cost of replacement.

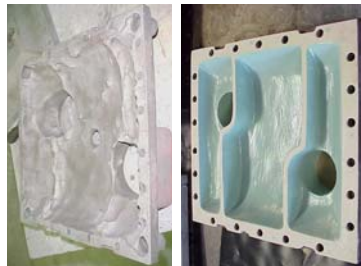
Left: This water box was blasted, decontaminated and exhibited severe corrosion, holes through the casing and the division plates almost completely corroded away.

Right: The same water box fully refurbished with 600 series and Kevlar matting.

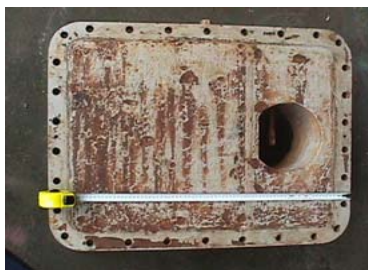
The end cover shown here was painted 5 times in 10 years with Epoxy paint. Under the paint it had corroded and there was deep pitting. The end cover was blasted, repaired and coated with Polyglass 600 series. There was no corrosion or maintenance required for the next 10 years.

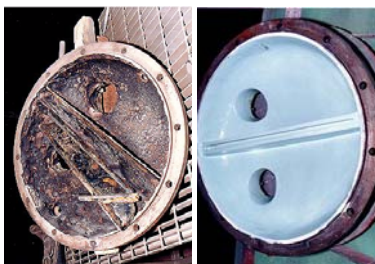
This cast iron end cover had been in service for 2 years and was severely corroded. The division plate was rebuilt with 600 series and matting. The sealing faces were machined back to their original dimensions. The end cover is corrosion protected and provided many years of trouble free service.

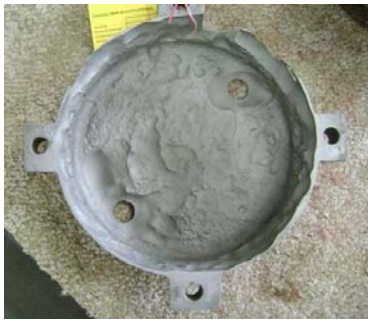
This condenser end cover was considered scrap, however Corrocoat were able to rebuild it using a composite laminate of 600 series and Kevlar matting. Two stainless steel sockets were welded in place and the end covers put back into service without the risk of future corrosion and at a fraction of the replacement costs.
