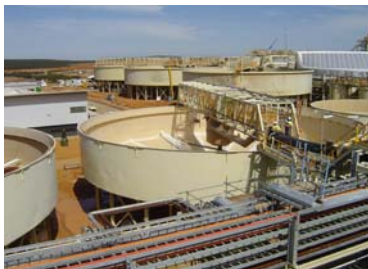
### Ravensthorpe Nickel Project

The Ravensthorpe Nickel project involved the lining of 53 tanks over a 20 month period. A total area of 36,634 m<sup>2</sup> was coated requiring 75,000 litres of Corrocoat material. Corrocoat products were selected after years of testing by BHP and Corrocoat's R&D chemists in the UK.

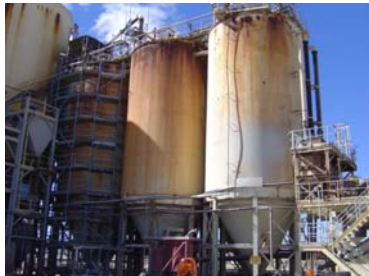
### Adsorption Tank Refurbishment

The existing tanks were severely corroded due to the activated carbon slurry. The tank was blasted, repaired and all pitting filled with Corroglass 600 series. The internals were then sprayed with 1000 microns of Polyglass VEF.

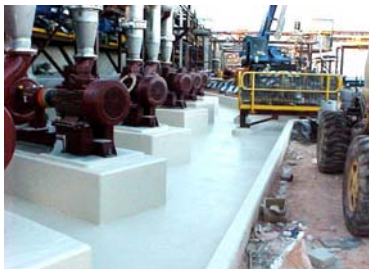
### Solvent & Acid Bund Coating

These pump plinths and sump were coated with Polyglass VEF to protect the concrete from degradation due to solvent and acid attack. Polyglass VEF was selected to reduce maintenance costs and to protecting the environment from the possibility of chemicals leaching through the concrete into the ground water.

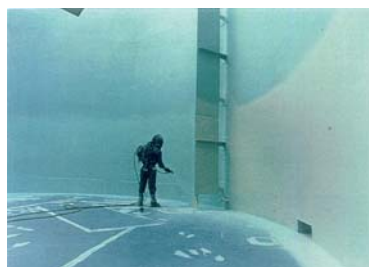
### CIL Tanks

This is one of 7 CIL tanks that were suffering from SRB's and associated corrosion under the original coating. The old coating was removed and the tanks and baffles coated with 1200 microns of Polyglass VEF which is totally unaffected by SRB's. All corrosion issues were eliminated.

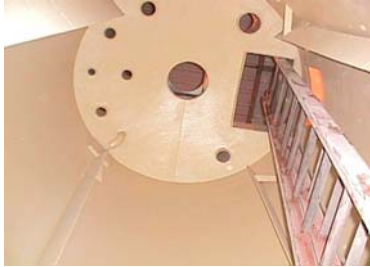
### Slimes De-copperising Tank

This tank contained sulphuric acid at high temperatures. In September 1999, Corrothane XT was selected to coat the tank walls, floors, roof, internal components and baffles to protect the mild steel substrate from the aggressive acid attack.

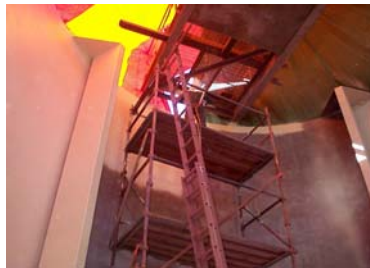
### Leach Tanks

In 1998 extensive testing was conducted to find a replacement lining for failing 6mm rubber lining in the Roxby Downs leach tanks. Polyglass VEF at 1mm thick was selected and applied by Corrocoat and the coating has operated without fault since that time.

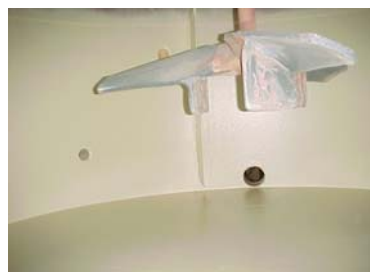
## Ferric Sulphate Tank

Within 6 months of this tank being lined the rubber had "cooked" and was missing in patches and there were holes in the tank floor under the acid inlet pipe. The environment in the tank is Ferric Sulphate at 95°C. Corrothane XT was spray applied at 1000 microns due to its high temperature tolerance up to 180°.

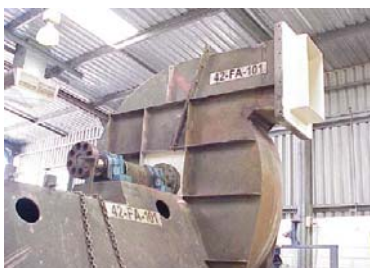
## Tiwest Chandala Fan Rebuild

This fan was severely corroded and eroded from wet sulphuric acid and H<sub>2</sub>S with abrasion from mineral sand. Significant savings were achieved by eliminating the need for a new fan and associated modifications to existing footings and ductwork. The coating prevents any future corrosion / erosion reducing maintenance and running costs.
