Tank Corrosion and Sulphate Reducing Bacteria (SRB,s)

Industry: Mining
Product: Polyglass VEF
Expertise: Internal Tank Coating

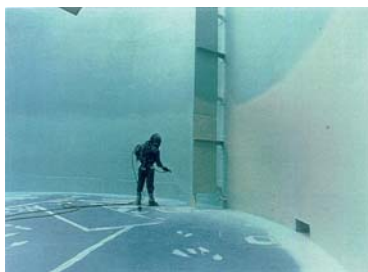
CIL Tanks

This is one of 7 CIL tanks that were suffering from SRB's and associated corrosion under the original coating. The old coating was removed and the tanks and baffles coated with 1200 microns of Polyglass VEF which is totally unaffected by SRB's. All corrosion issues were eliminated.

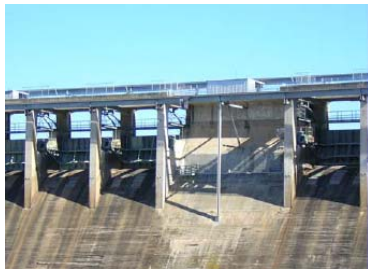
Spillway Gates— Victoria

Access to the gates was difficult and expensive and the original coating required maintenance after two years. Corrocoat removed the existing coal tar epoxy and replaced it with Polyglass VEF. HTE was applied to the rubbing areas because of its excellent abrasion resistance. The new coating has required no maintenance for 9 years.

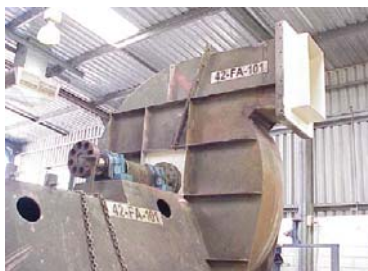
Tiwest Chandala Fan Rebuild

Severe Erosion & Corrosion of Duplex Stainless Steel Fan Casing & Impeller

This fan was severely corroded and eroded from wet sulphuric acid and H₂S with abrasion from mineral sand. Significant savings were achieved by eliminating the need for a new fan and associated modifications to existing footings and ductwork. The coating prevents any future corrosion / erosion reducing maintenance and running costs.

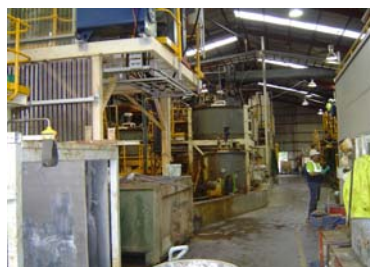
Mineral Processing Plant

Chemical spills and an aggressive acidic atmosphere were damaging the structural steel and equipment in this mineral processing plant. Polyglass VEF was applied to all steelwork and equipment to increase the life of the structure, plant and equipment.

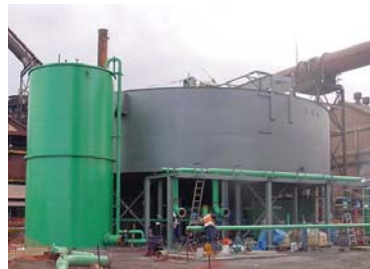
Blast Furnace Water Treatment Plant

The process environment is seawater with traces of ammonia and sulphuric acid with a pH of 7 to 8.5 at 50°C to 82°C. The high chloride content at elevated temperatures results in rapid corrosion of the steel tank and components. Polyglass VEF was used to eliminate all corrosion issues.

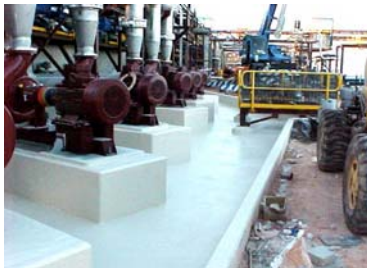
Solvent & Acid Bund Coating

These pump plinths and sump were coated with Polyglass VEF to protect the concrete from degradation due to solvent and acid attack. Polyglass VEF was selected to reduce maintenance costs and to protecting the environment from the possibility of chemicals leaching through the concrete into the ground water.

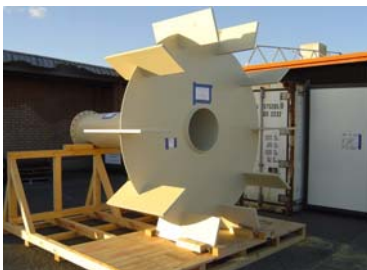
Feedwell Turbine

This feedwell turbine is just one of the components sprayed internally and externally with 1200 microns of Polyglass VEF. The turbine is subjected to high chloride and sulphide at temperatures in excess of 85°C

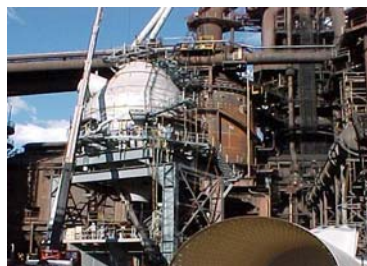
High Temperature Coating of New Dust Catcher and Crude Gas Main

This new dust catcher for Blast Furnace No.2 required a 15 year design life. A combination of Polyglass VEF and Corrothane XT were used under the refractory tiles to provide corrosion protection. Even the cow horn refractory anchors were fully coated.
