► High performance anti-corrosion industrial coating systems

Overcoming Microbial Induced Corrosion

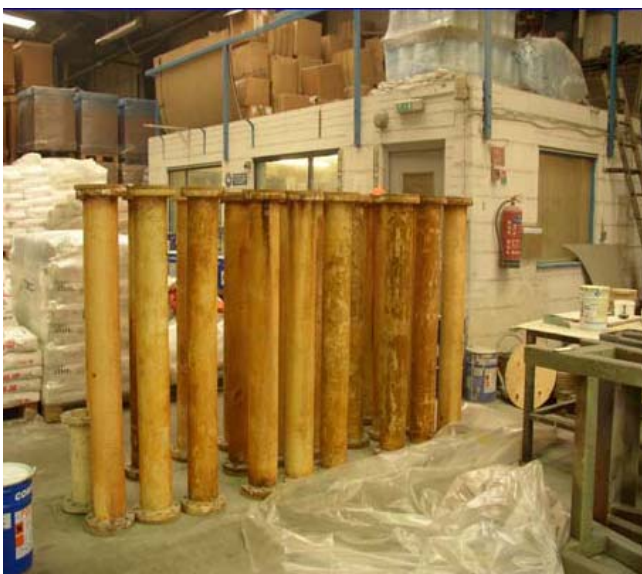
Riser pipes after 21 years in seawater

In 1983 Corrocoat were asked to specify a coating system for carbon steel seawater riser pipes destined for an oil rig in the North Sea. The application was for external exposure to seawater (immersed, splash zone and atmospheric) and internally warm seawater with low hydro chlorite dosing. Corrocoat specified our standard Polyglass coating to both internals and externals of the riser pipes. In 2004, twenty one years later, the riser pipes were removed for review and inspection. The coating revealed only minor mechanical damage that occurred during removal of the pipes. Overall the pipes spools were found in excellent condition with only minor surface staining.

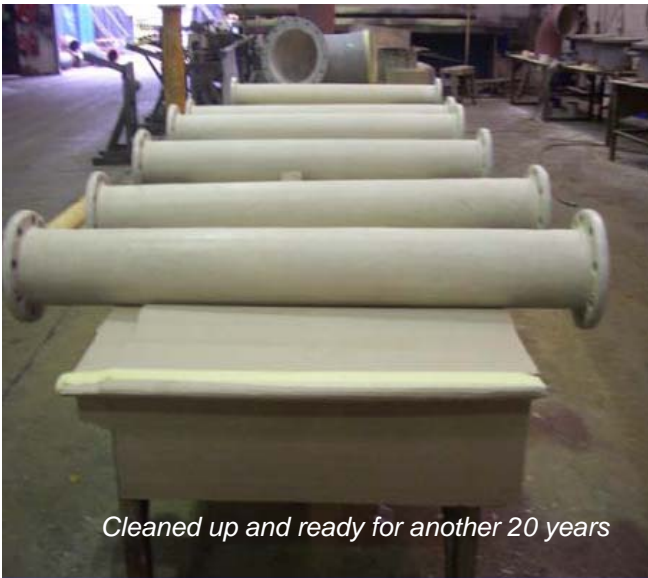
Cleaned up and ready for another 20 years

The existing coating on each pipe spool was flash blasted and flange areas, damaged during the removal of spools, were grit blasted to Sa 2 ½ with a mini-

imum surface profile of 50µm. The flanges were then coated with a new technology product, Corroglass 600 series, to a minimum dry film thickness (dft) of 1.5mm, and finally spark tested to 19Kv Hv-AC. The spools were put back into service with a life expectancy of a further 20 years.
