► High performance anti-corrosion industrial coating systems

Winter is the Time to Protect your Chiller

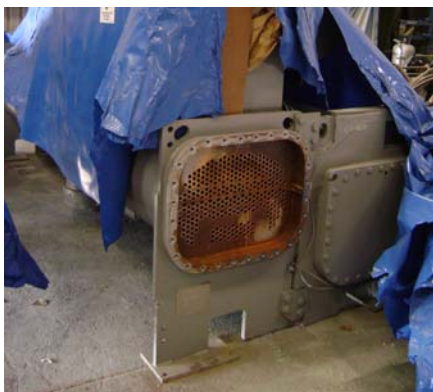
A new chiller exhibits corrosion from its factory testing.

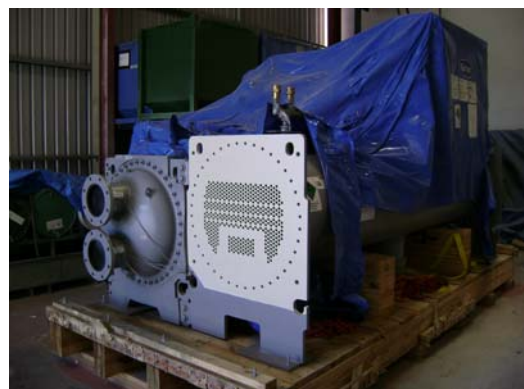
A chiller tube sheet after treatment with Corrocoat VEF

- anodes.
- Protect all exposed surfaces with Corrocoat glass flake vinyl ester coating.
- Include anodes after coating for increased protection.

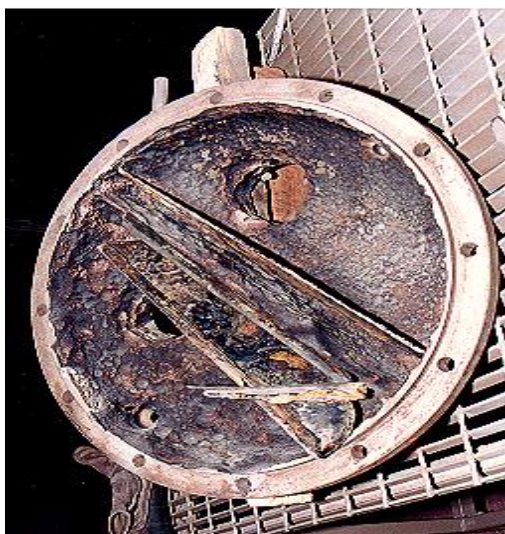
An un coated cast iron end cover after 2 years service
