### Immersion Test

#### Coal Tar Epoxy Vs Biofoul

### Non Toxic Anti Foul For Seawater Screens

#### Structural Steel Work

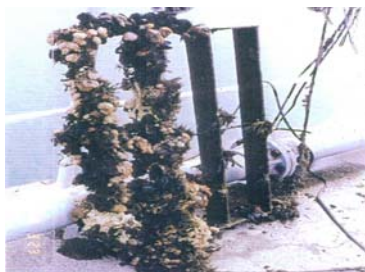
The left half of this frame was coated with coal tar epoxy, the right half coated with Polyglass and Biofoul. The frame was then immersed off Japan for 19months. The results speak for themselves. Biofoul is a long life, heavy duty anti foul and can be applied to coated steel, plastic, wood and concrete. It can be used as a gel coat for GRP.

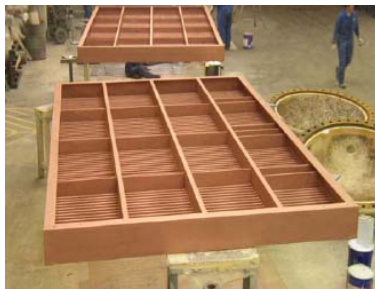
These screens were suffering from corrosion and marine growth. Corrocoat, blasted, decontaminated and patched, the screens were then applied with a 1.5mm coating of Polyglass 600 series to eliminate any future corrosion. A top coat of environmentally friendly Biofoul was applied to the screens as a long term anti foul treatment. The use of Biofoul has eliminated the costly requirement for regular cleaning and maintenance by divers.

**Industry:** Power  
**Product:** Corrocoat, blasted, decontaminated and patched, the screens were then applied with a 1.5mm coating of Polyglass 600 series & Biofoul  
**Expertise:** External Coating of Sub Sea Steel
